# Manhole Inspection Summary

Manhole # S29KK\_012MH

Insp Date: **7/18/07 11:22 AM**

**Location** Address: **702 LENNOX ST**

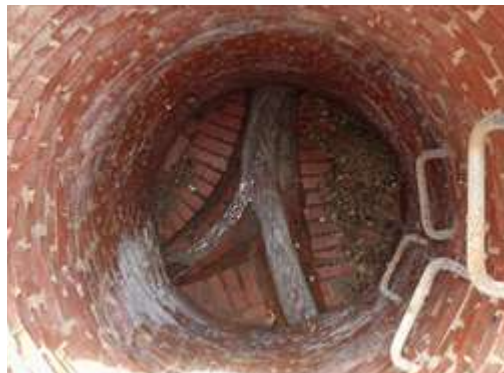
Top View

☒ **Debris** (not Condition related)

Count: **5** Missing: **0** ☒ **Corroded**

Corroded steps. Bench debris.

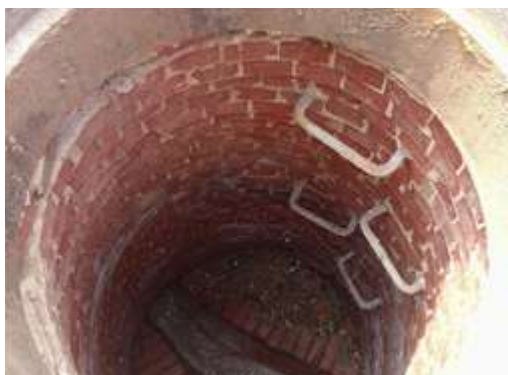
Defect

☒ **Leaks**

Condition: ☐ Sound ☐ Cracked ☐ Root Intrusion ☐ Loose Brick ☒ **Deteriorated**

Infiltration: ☐ None ☒ **Joint** ☐ Cracks ☐ Mortar ☐ Roots ☒ **Wall**

Infiltration: ☐ None ☐ Joint ☐ Cracks ☐ Mortar ☐ Roots ☒ **Wall**

Frame leaks. Adjustment deterioration and infiltration. Barrel infiltration - other side.

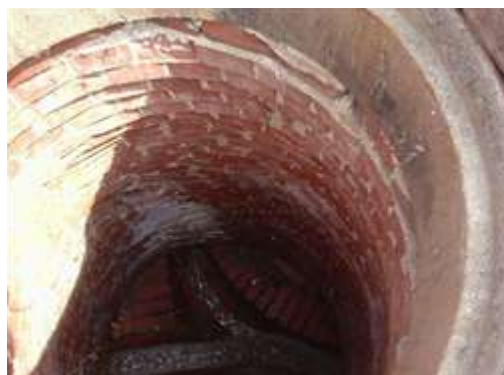
Defect

Frame leaks. Adjustment deterioration and infiltration. Barrel infiltration.

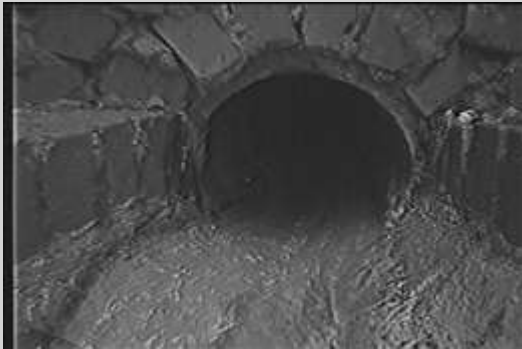
### 10 in. Circular Gravity Sewer Pipe Out @ 12 O'Clock

Barrel deterioration and infiltration.

Infiltration: **Evidence** Pipe Seal Cond: **Cracked**

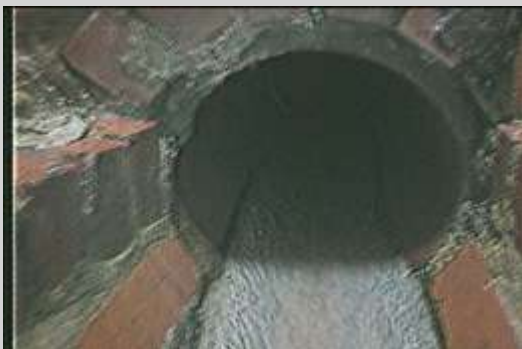
### 10 in. Circular Gravity Sewer Pipe In @ 5 O'Clock

Infiltration: **Evidence** Pipe Seal Cond: **Unknown**

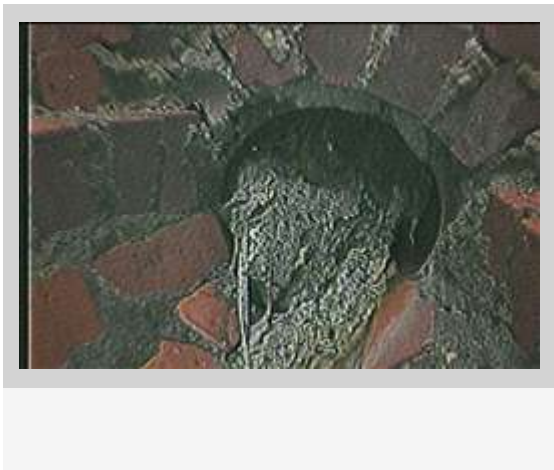
Pipe In @ 8 O'Clock

Deposits: ☐ None ☐ Mud ☐ Sludge ☒ **Debris** ☒ **Grease**

Silt Depth: **6** (in.) Deposits Extent: **Heavy**

Infiltration: **Evidence** Pipe Seal Cond: **Cracked**
